NIOSH
Fire Fighter Fatality Investigation
and Prevention Program

Roof Collapse Injures Four Career Fire Fighters at a Church Fire- Arkansas

Fatality Assessment and Control Evaluation Investigative Report #F2001-03

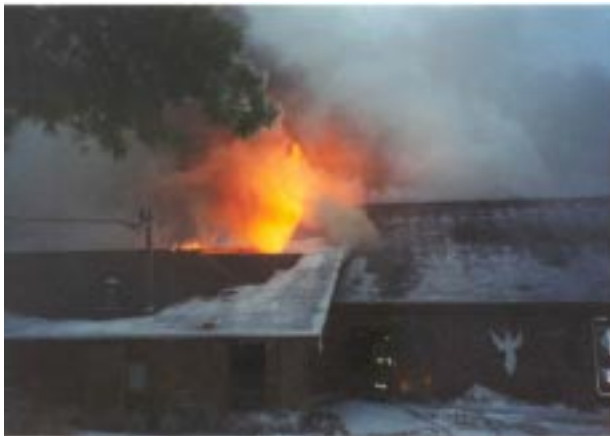
Structure Involved in this Incident

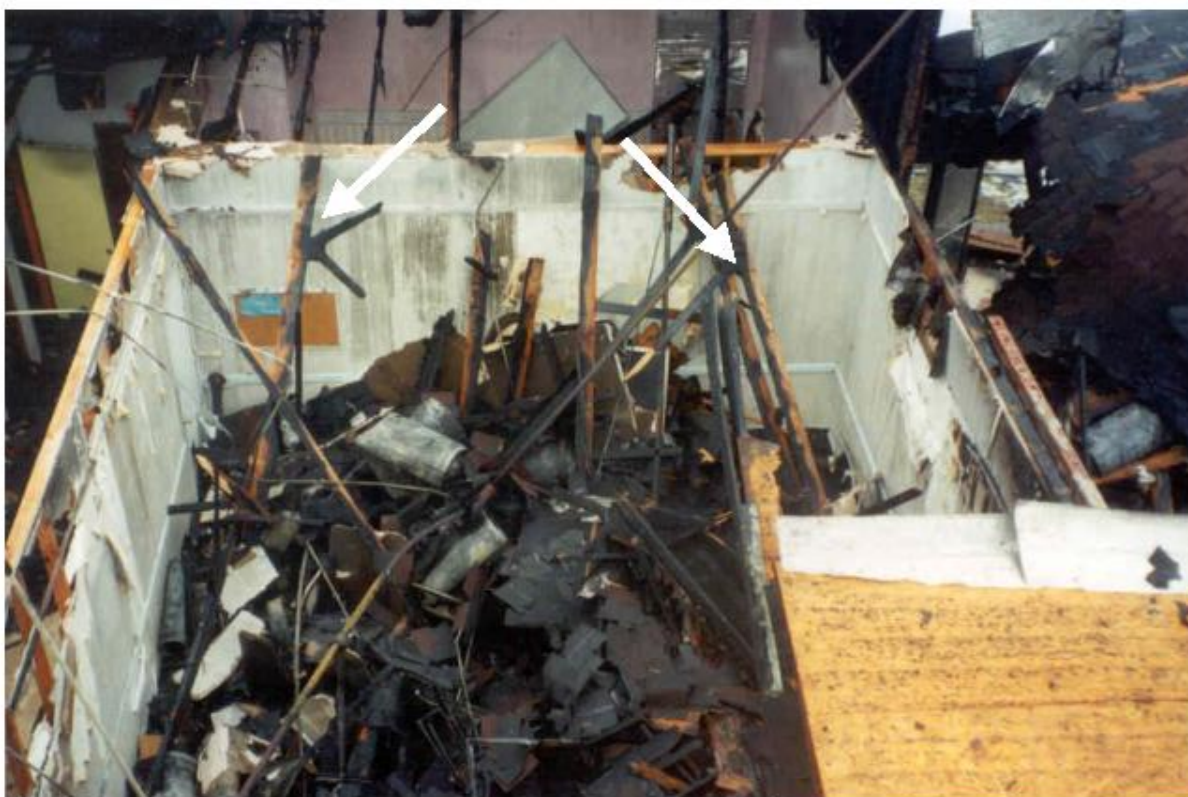
Photo 1. Truss and Gusset Plates

Discussion: The lightweight wood truss incorporates wooden members which can be as small as 2- by 4-inch timber connected with metal gusset plates.

The trusses are designed according to specified load amounts. The loads are generally heating, ventilation, and air conditioning (HVAC) units, compressors, air ducts, cooling lines, rest room ventilation fans, grease exhaust ducts and exhaust fans, snow, and ice. Additional loads, which could be applied after the truss is in place, are antennas, satellite dishes, flags, banners, large air-filled advertisements with air blowers, and improperly stored items. The trusses are designed to distribute the loads throughout the roof system and can span large openings without interior load-bearing walls. Since the trusses are tied together and are designed to distribute the load, if one of the trusses fails, it places an additional load on the others, which could cause a chain reaction of failure leading up to a collapse. The document, *Building Construction for the Fire Service*, states that "the metal gusset plates can also be weakened or destroyed by fire by acting as a heat collector, delivering the heat to the metal gusset plate teeth, which can pyrolytically destroy the tensioned wood fibers, which had been gripping the metal teeth. Sometimes trusses are set in multiples to cope with a concentrated load. This does not suffice in a fire because all the trusses can be exposed to the same fire conditions. An additional load not incorporated into the design can shorten the time to failure in a fire. When a fire occurs in this type of truss, it generally travels rapidly throughout them reducing their structural integrity."³

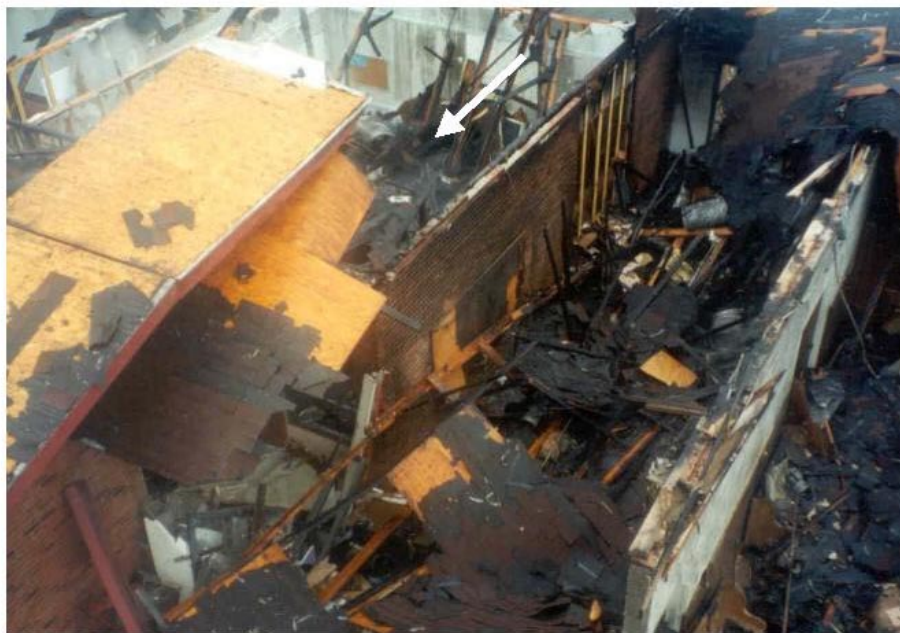
Photo 3. Collapsed Area

On December 28, 2000, four fighters from a career fire department responded to a structural fire at a local church. The fire was started by electrical wiring in the truss void at approximately 0715 hours. A 49-year-old captain (Injured Fire Fighter #1), a 28-year-old fire fighter/engine operator (Injured Fire Fighter #2), and two 27-year-old fire fighters (Injured Fire Fighters #3 and #4) were injured while performing interior suppression activities when a section of the roof collapsed, trapping the four fire fighters.
